Manhole Inspection Summary

Manhole # S250__024MH

Insp Date: **4/1/08 11:00 AM**

Location Address: **1101 Bayard**

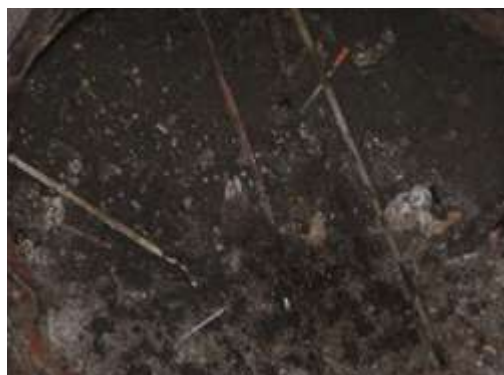
Defect

Condition: ☐ Sound ☐ Cracked ☐ Root Intrusion ☐ Deteriorated ☐ Leaks ☒ **Debris**

debris in channel

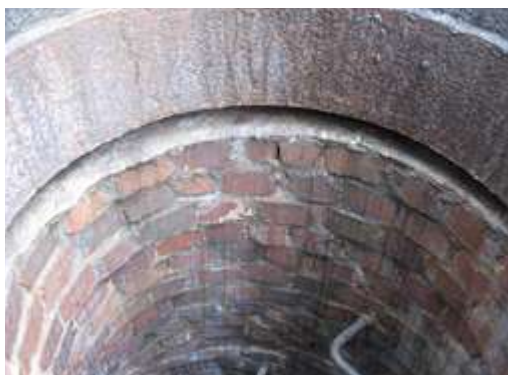
Defect 2

Condition: ☐ Sound ☒ **Cracked** ☐ Root Intrusion ☒ **Loose Brick** ☐ Deteriorated

Condition: ☐ Sound ☒ **Cracked** ☐ Root Intrusion ☐ Loose Brick ☐ Deteriorated

missing brick and mortar under frame (loose bricks in chimney), Cracks in chimney and corbel, chimney infiltration

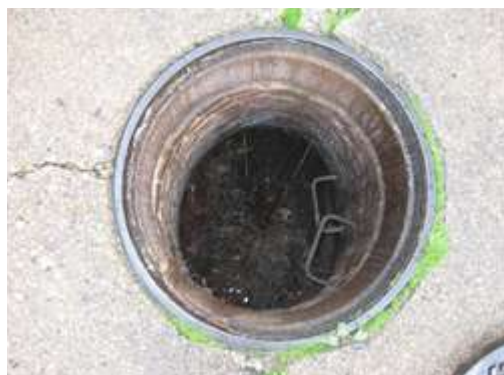
Defect 1

Condition: ☐ Sound ☒ **Cracked** ☐ Leaks

Frame cracked (grass growing through)

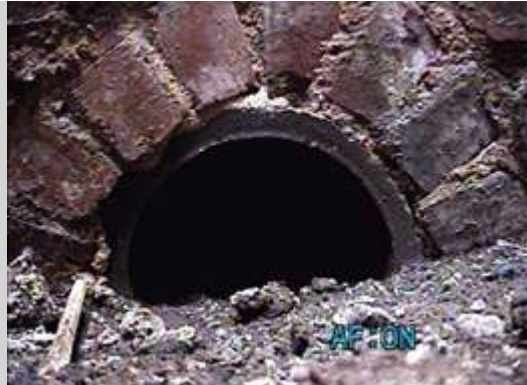
12 O'Clock Outflow

sediment and debris in channel
